JULY 2019

VEHICLE ESCAPE TOOL EVALUATION

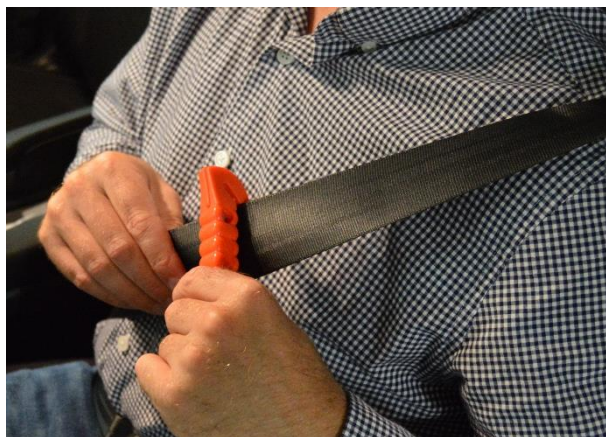
The seat belt-cutting component of most vehicle escape tools consists of a recessed blade used to catch the belt and slice through the material. The blade is recessed to prevent injury to the user while allowing the belt material to slide into it.

Figure 5: Example of seat belt cutting tool. Image Source: AAA

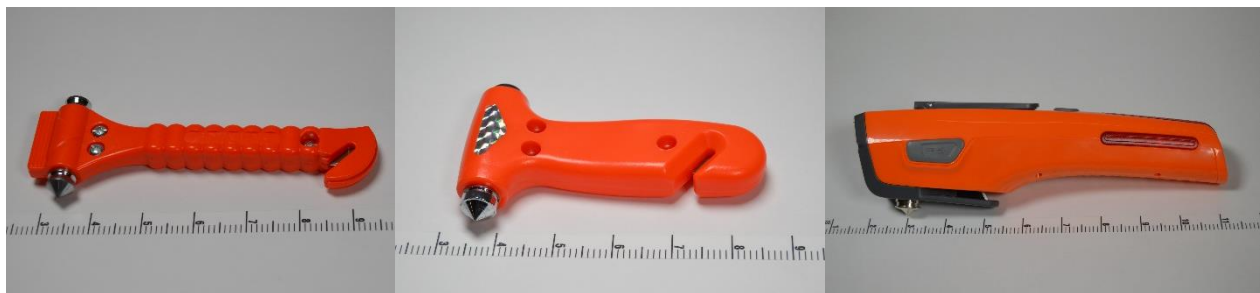
Figure 7: Hammer-style tools. Left to right: Tools No. 1, 2, and 3. Image Source: AAA

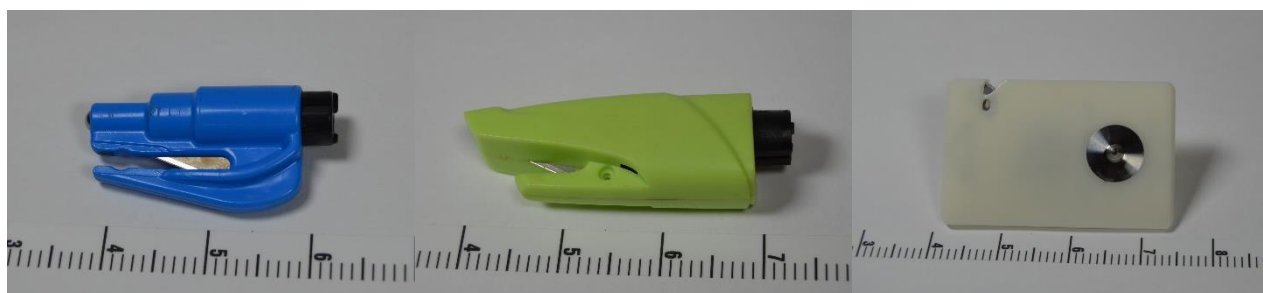
Figure 8: Spring-loaded tools. Left to right: No. 4, 5, 6. Image Source: AAA

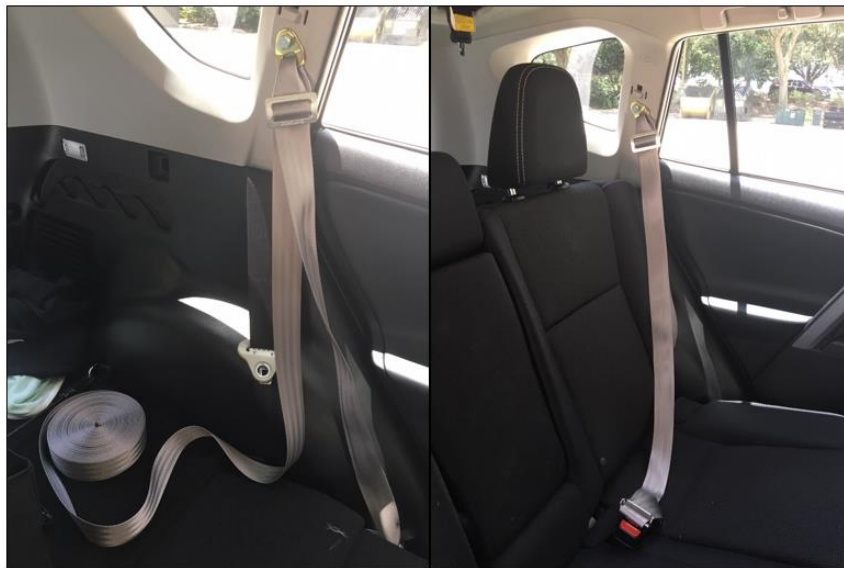
The original seat belt in the test vehicle was removed from the shoulder mount and replaced with a new bracket and webbing for the purpose of repeating the seat belt cutting test (see figure below). The free end of the roll was first fed up through the bottom bracket then through the top bracket and back down through the bottom bracket. The free end of the belt was then looped through the back end of the seat belt tongue, which would hold the free end of the seat belt in place when pulled tight.

Figure 9: Setup for seat belt-cutting test. Image Source: AAA

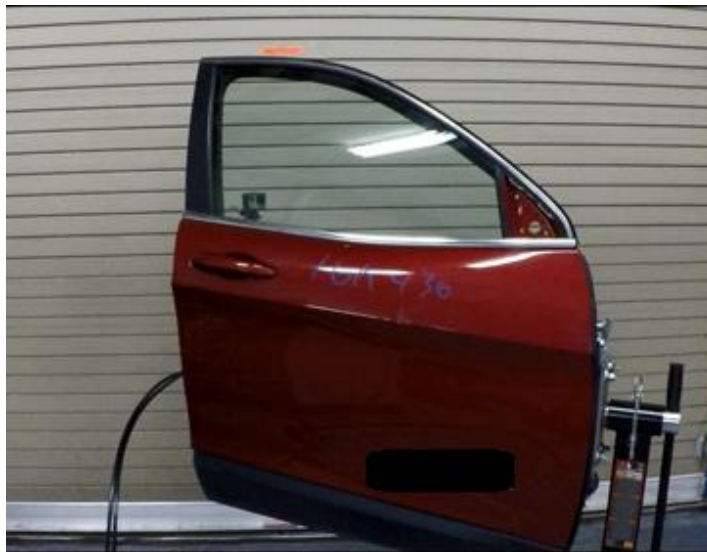
Figure 11: Setup for window-break testing. Image Source: AAA

A right-front door from a mid-size SUV was selected due to the original equipment manufacturer (OEM) option for both laminated and tempered glass. The door was mounted on a stand to hold it in a rigid, vertical position for testing. For the spring-loaded tools, no further equipment was required. An AAA researcher, protected with eyewear, gloves and a lab coat, manually pressed the tools into the glass. However, for the hammer tools, a mechanism was required to swing the tools precisely and reliably. A human operator would not be able to precisely repeat swings at the same speed, force and location. The equipment and methods used for this test procedure are outlined below.

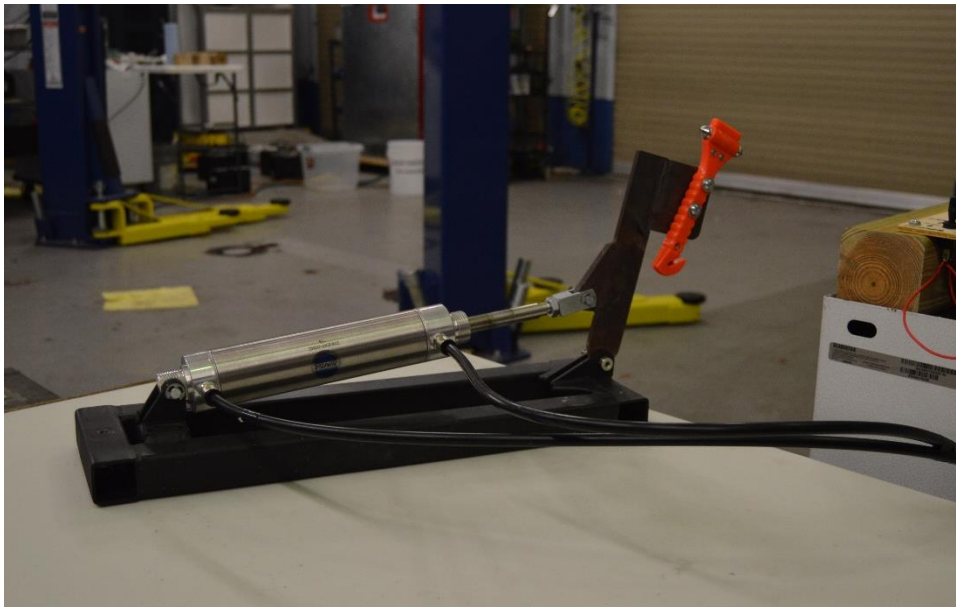
A pneumatic arm was fabricated in-house to swing the hammer tools. The frame of the arm was mounted onto the test door so that the hammer would swing upward into the window. Tools were secured to the end of the arm using two bolts. The arm was controlled by a two-way solenoid valve connected by two, approximately 10 foot air tubes that allowed operators to be at a safe distance during testing. A picture of the arm on the test stand can be seen below.

Figure 12: Pneumatic arm for hammer tool testing. Image Source: AAA

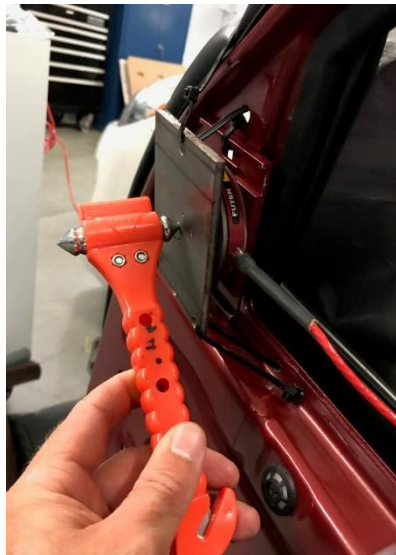
To calibrate the arm, it was necessary to determine a value to represent an average human swing. A load cell was mounted vertically to represent a vehicle side window, and data from the cell was collected at a rate of 5000 Hz to accurately measure the sharp impact force. A small group of AAA employees consisting of two females and two males (ages 25-40) were seated next to the load cell as if they were seated in a vehicle. They were asked to swing a hammer tool as if they were trying

to break a window during an emergency. The measured peak forces produced an average value of 217 lbs. This was used as the target force for calibration of the pneumatic arm.

Once the target force was determined, the arm mounted with too, was positioned so that it would strike the load cell as the volunteers had done. Repeated swings were made, measuring the force of each, with incremental adjustments in air pressure being made until the arm repeatedly produced a peak force of 217 lbs.

Figure 13: Load cell and hammer used for measurement of impact force. Image Source: AAA

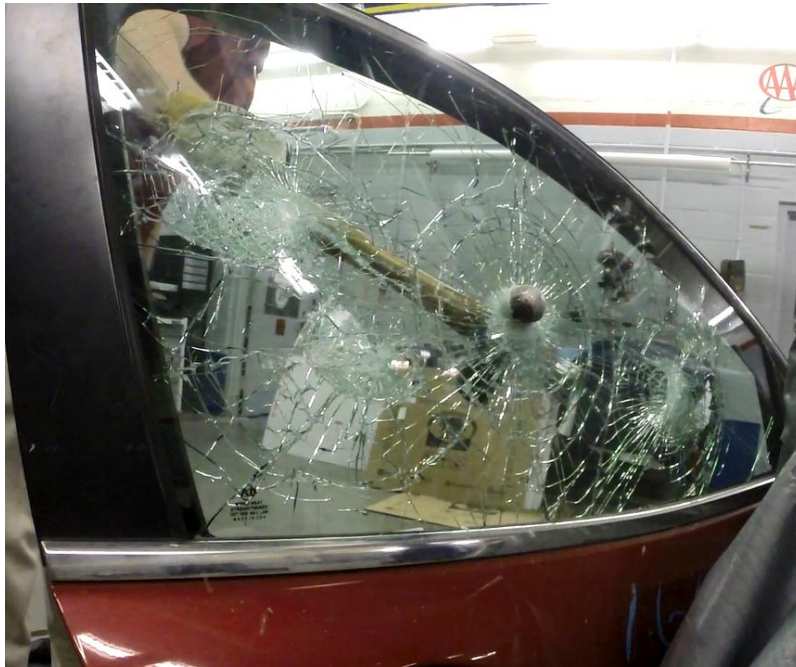
To illustrate the strength of laminated glass, after testing was complete, an AAA researcher used a ball-peen hammer to attempt to break through the glass. Even after multiple strikes in the same location, the glass stayed intact such that could not be removed from the frame. This was performed for demonstration purposes only - a hammer should not be considered a replacement for a vehicle escape tool. Emergency personnel may use specialty tools, such as the one shown in Figure 19, designed to punch through and then cut laminated glass. These tools are not intended for civilian use, as they tend to be large, potentially dangerous and require specialized training.

Figure 18: Attempt to break laminated window with ball-peen hammer. Image Source: AAA

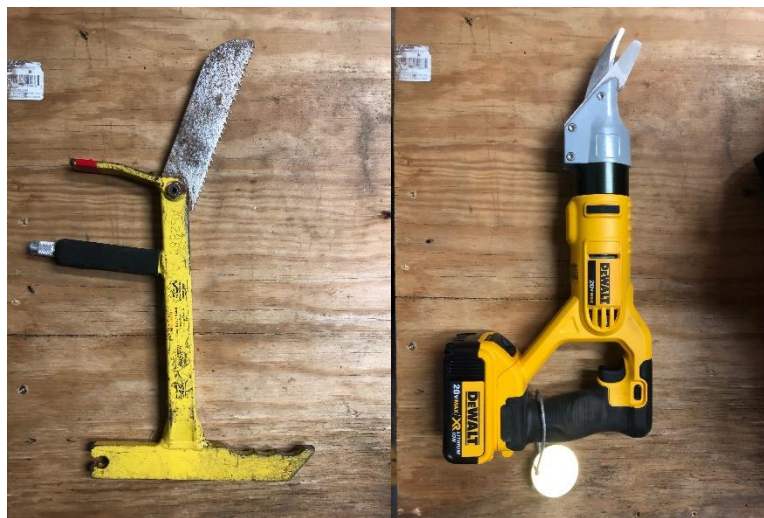
Figure 19: Examples of professional glass removal tools. Image Source: Orange County Fire and Rescue
